NATIONAL PROGRAM FOR INSPECTION OF NON-FEDERAL DAMS
UPPER LAKE PHIPPS DAM. (U) CORPS OF ENGINEERS WALTHAM
MA NEW ENGLAND DIV JUL 80

COVE RIVER BASIN
WEST HAVEN, CONNECTICUT

UPPER LAKE PHIPPS
DAM NO.1 - CT 00109
DAM NO.2 - CT 00110

PHASE I INSPECTION REPORT
NATIONAL DAM INSPECTION PROGRAM

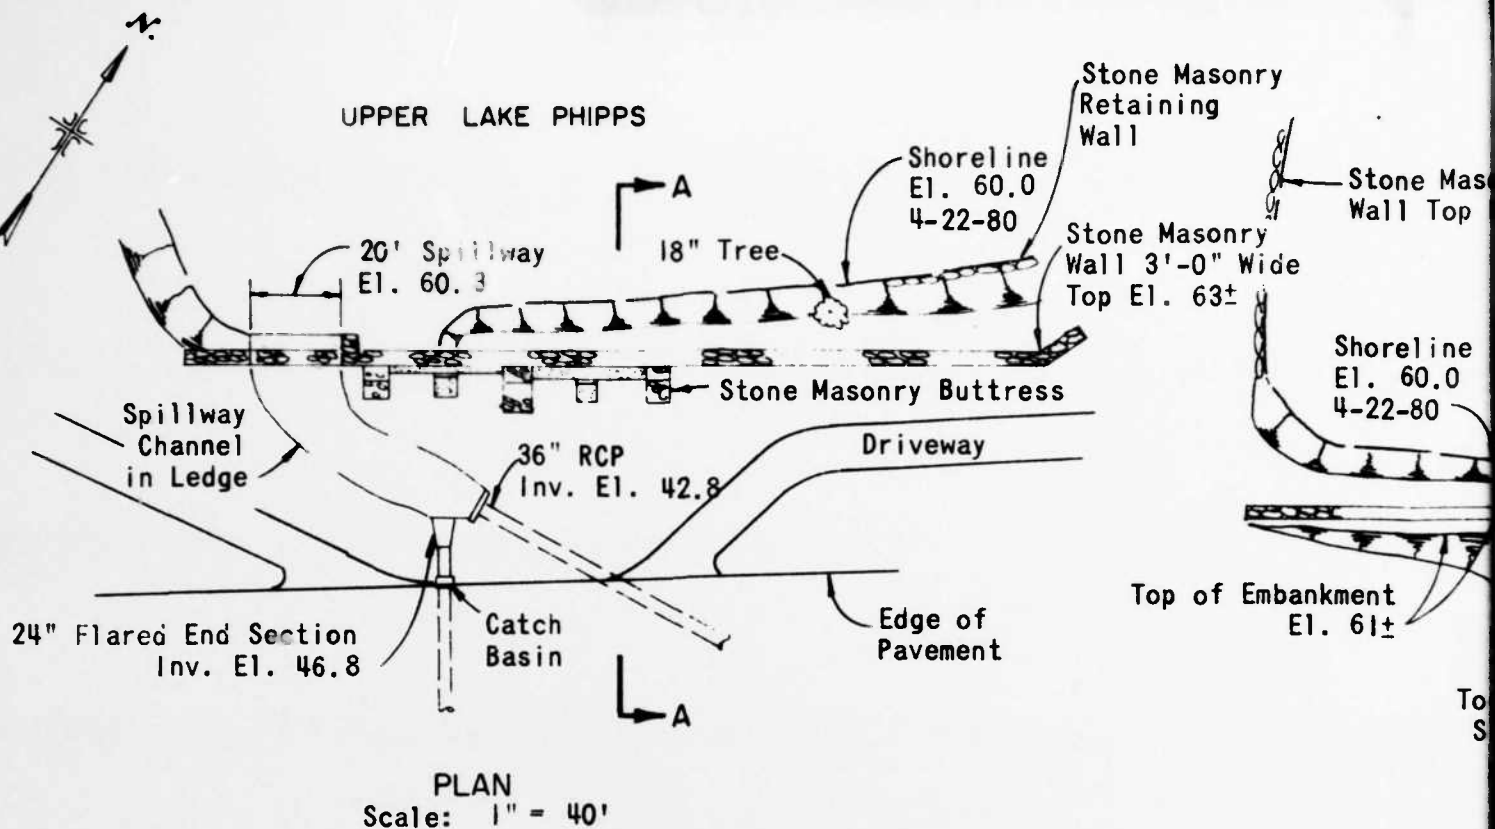
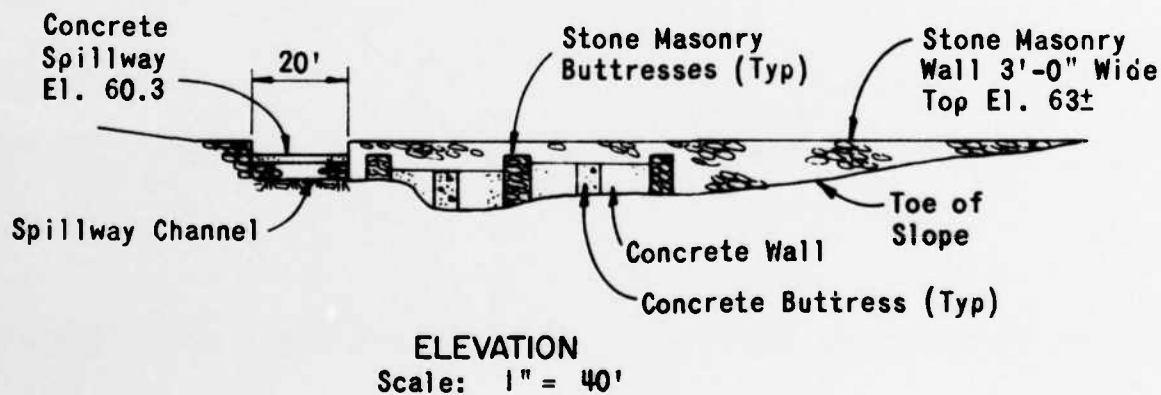
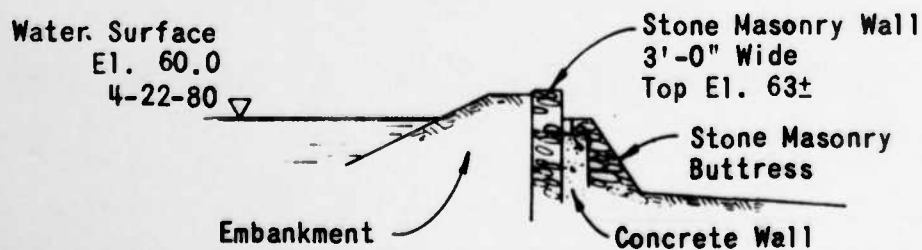
FIGURE 2

Dam No. 2 consists of a stone masonry and concrete buttress wall with an upstream earth embankment. The dam has a maximum height of 14 feet, an upstream slope of 2 horizontal to 1 vertical, and an overall length of 190 feet including a 20 foot long overflow spillway located at the right end of the dam. The dam has a top width of approximately 8 feet including the top of the masonry wall which is 3 feet wide. There are three stone masonry buttresses spaced 30 feet on centers beginning at the left end of the spillway and continuing toward the center of the dam. It appears that a concrete facing was placed against the wall between the stone masonry buttresses and that two additional concrete buttresses were added between the stone masonry buttresses. See Figure 2, page B-1 in Appendix B. The concrete facing varies in thickness from a minimum of 12 inches for the section adjacent

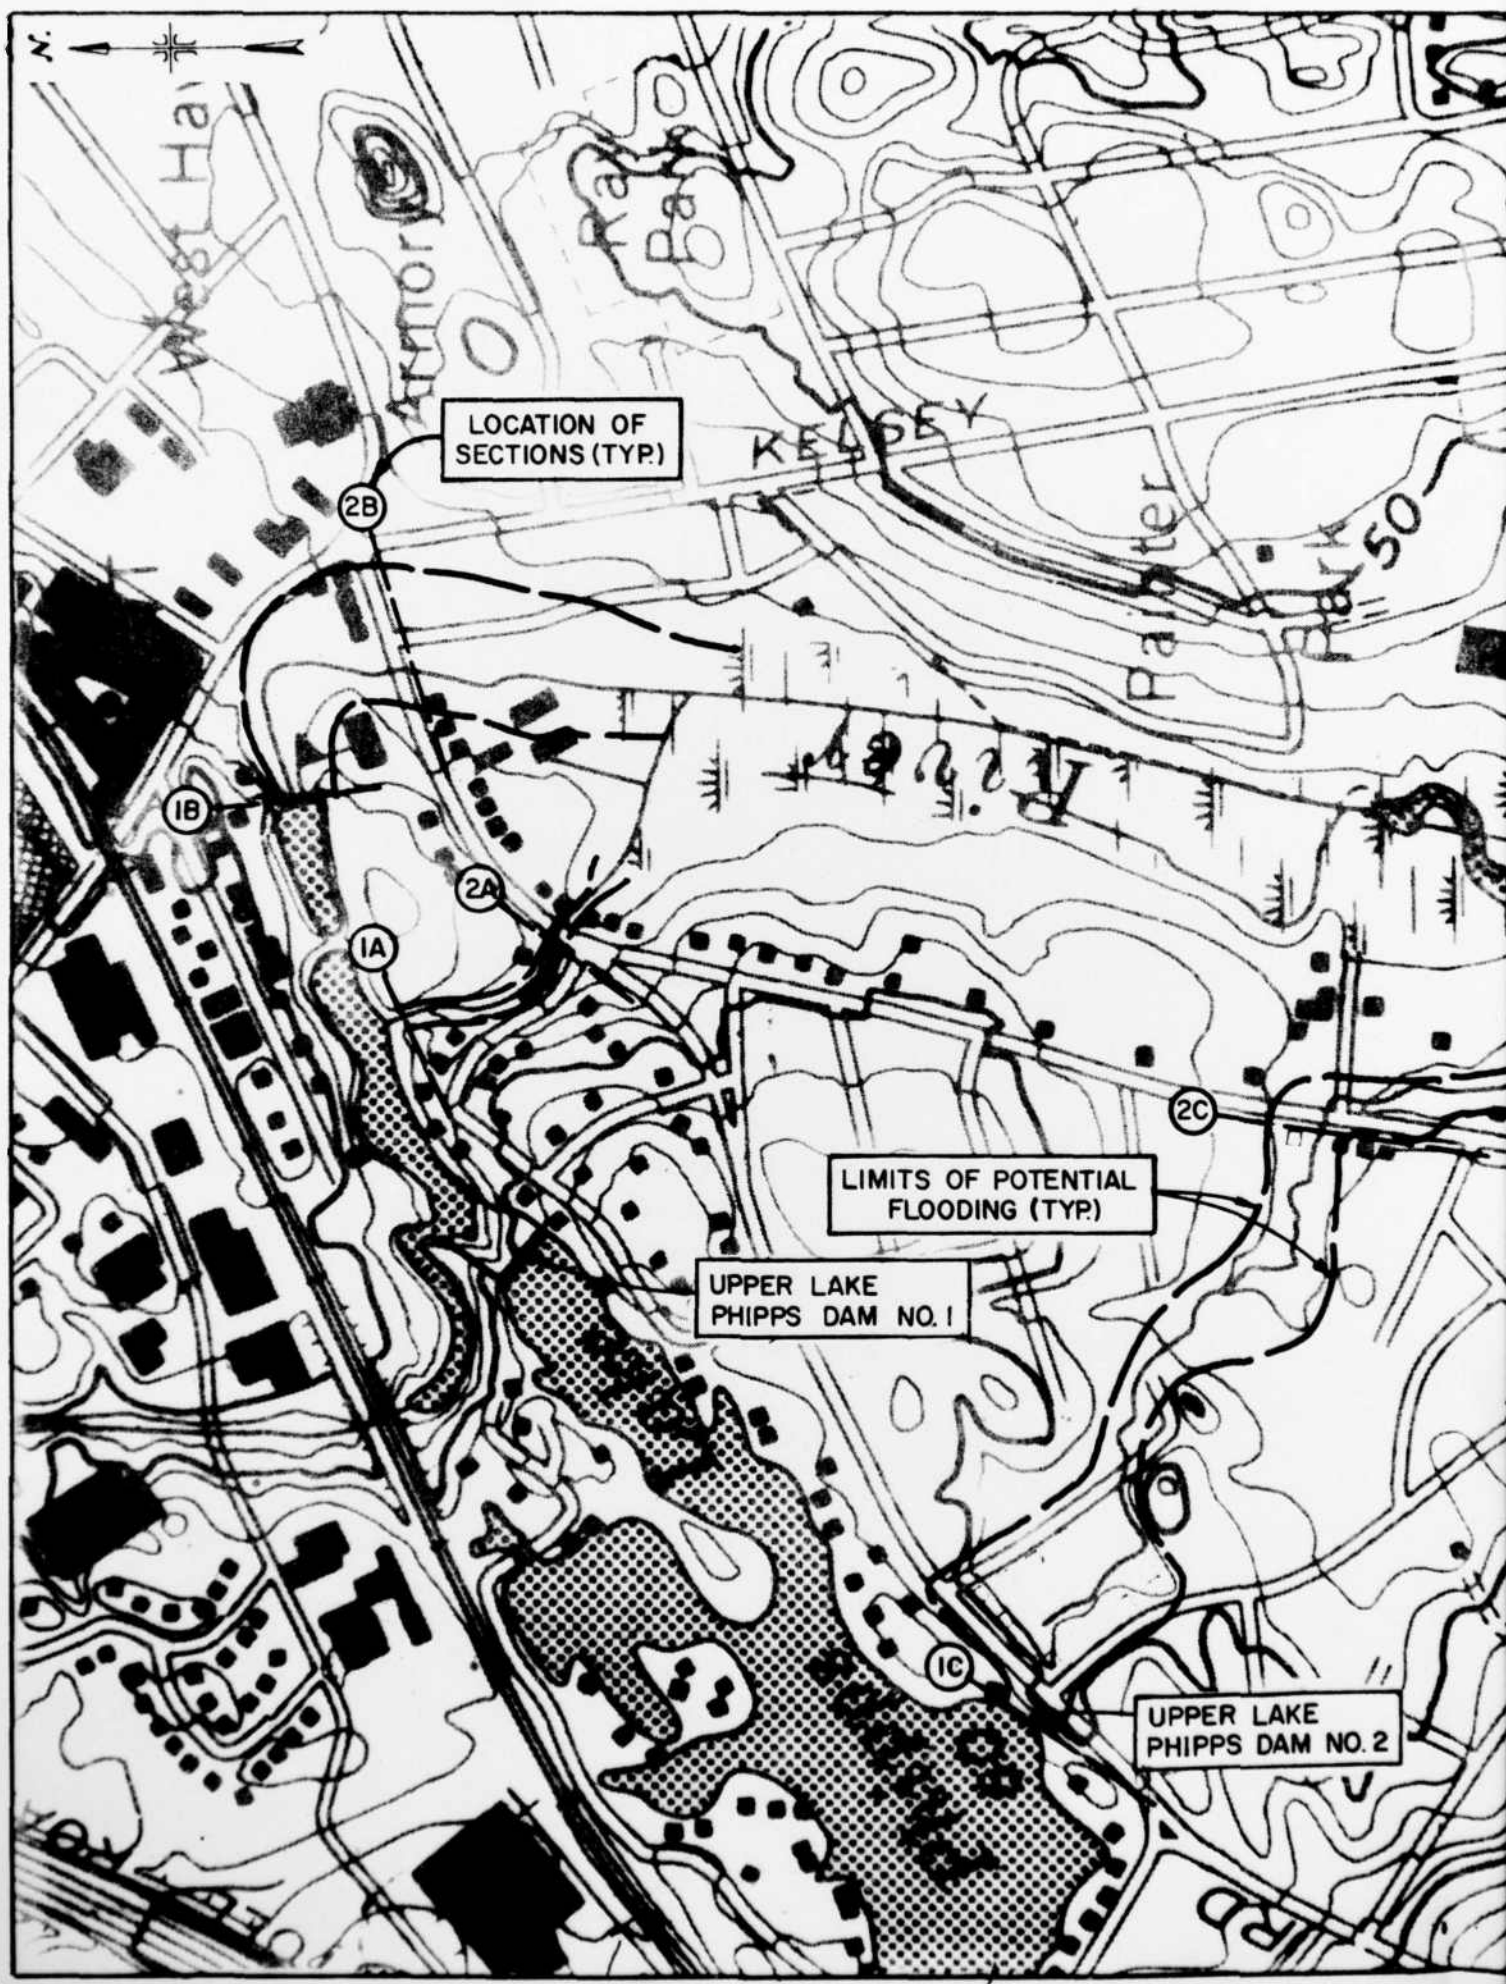
FIGURE 5

The dam breach for Dam No. 1 would release up to 10,500 cfs into Lower Lake Phipps directly below the dam. The flood waters would exit Lower Lake Phipps in two places; at the small brook on the south side of the Lake (Section 1A), and over the dam at the east end of the Lake (Section 1B), see Figure 5 in Appendix D. Flows at Section 1A are estimated at 1260 cfs and would flow down the stream without affecting any homes. The flood waters would overtop Main Street (Route 162), Section 2A, by about 2 feet and

The flood waters would inundate 2 houses at Route 162 to about one foot above the eills.

From Route 162 the flood waters would flow within the stream channel and discharge to the tidal marsh without further damage.
